# DDASaccident274

Humanitarian Demining Accident and Incident Database  
*AID*

# DDAS Accident Report

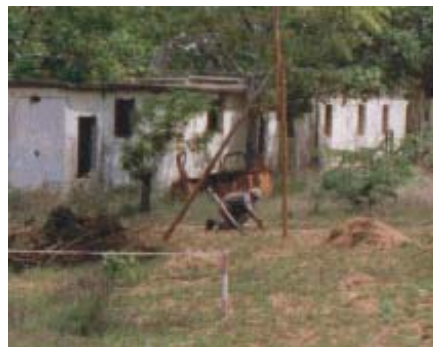
[The picture above shows a deminer excavating a detector reading. This is a "still" from a video made at the site during research in 1999.]

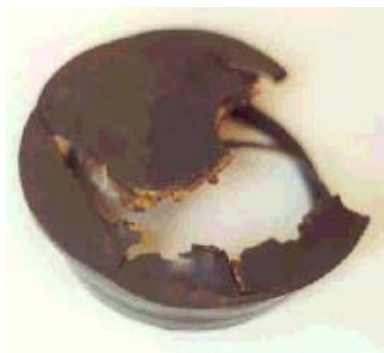
The crater opened by the explosion was about 17cm wide (across) and about 14cm deep.

[The picture above shows the rubber top of the Gyata-64 mine after the accident – clearly illustrating that the mine did not detonate as designed (photographed by the researcher later).]

The position of the mine on its side in the ground could have been the cause of the accident.

During the excavation, the victim did not verify the depth of the mine. In trying to correct this, and due to the mine being at an angle of about 20 degrees, he struck the upper part of the mine and detonated it. Therefore the accident was caused by a bad digging technique and the angled position of the mine.

The demining group's own site investigation and an examination "of the fragments" indicated that the HE in the mine "was possibly in a degraded state". The facts that the trowel "remained intact" and there was no fragment damage to the deminer's "body armour" and visor were taken as evidence supporting the idea that the explosive in the mine had "degraded".

Detection techniques capable of finding minimum metal and mines on their side must be used. Excavation techniques must otherwise be used.

A demonstration on proper digging methods should be made and all Team Commanders told to use these methods.
